Manhole Inspection Summary

Manhole # S45CC_050MH

Insp Date: **12/8/08 10:31 AM**

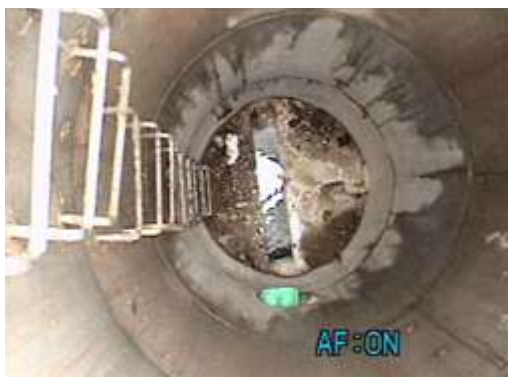
Defect

Infiltration: ☐ None ☐ Joint ☐ Cracks ☒ **Mortar** ☐ Roots ☐ Wall

barrel infiltration

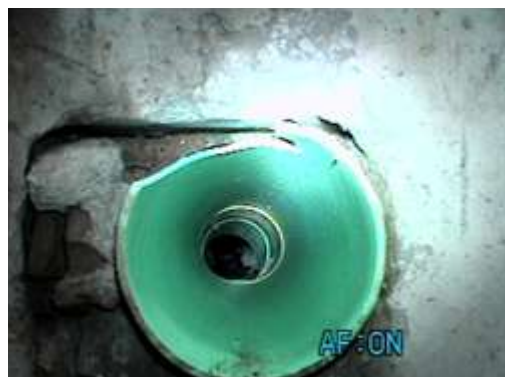
Defect

Condition: ☐ Sound ☐ Cracked ☐ Root Intrusion ☐ Loose Brick ☒ **Deteriorated**

Barrel wall deteriorated

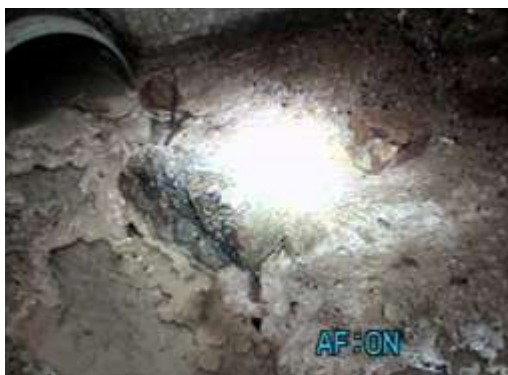
Defect 3

Condition: ☐ Sound ☐ Cracked ☐ Root Intrusion ☐ Deteriorated ☐ Leaks ☒ **Debris**

channel debris

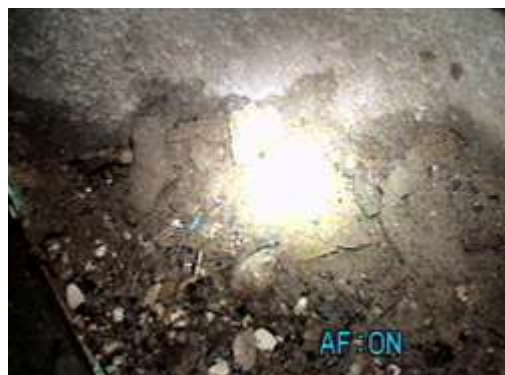
Defect 2

Condition: ☐ Sound ☐ Cracked ☐ Root Intrusion ☐ Deteriorated ☐ Leaks ☒ **Debris**

bench debris

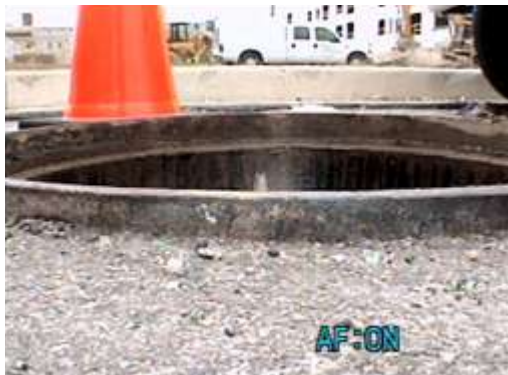
Defect 1

Diameter: **32** (in.) Length: **0** (in.) Dist A/B Grade: **2** (in.)

above grade

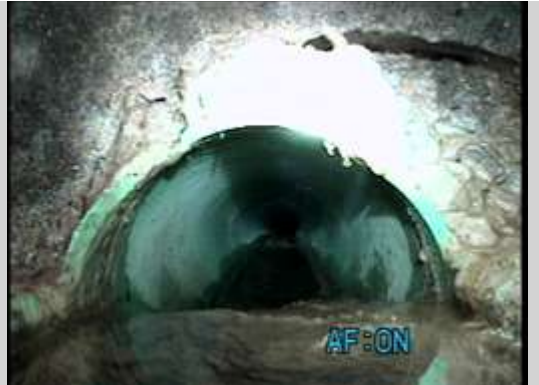
12 O'Clock Outflow

10 in. Circular Gravity Sewer
Pipe Out @ 12 O'Clock

Invert Depth: 14.16 (ft.) Flow Characteristics: Slow

Deposits: ☒ None ☐ Mud ☐ Sludge ☐ Debris ☐ Grease

Infiltration: None Pipe Seal Cond: Unknown

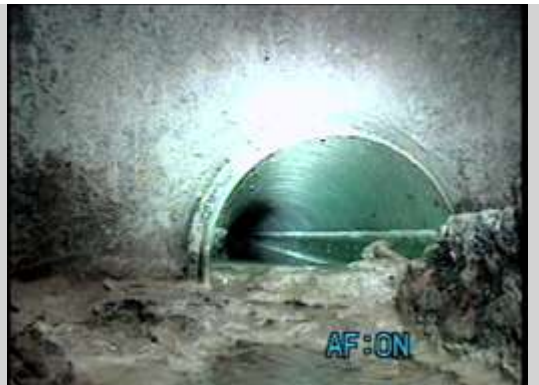
3 O'Clock Inflow

10 in. Circular Gravity Sewer
Pipe In @ 3 O'Clock

Invert Depth: 13.88 (ft.) Flow Characteristics: Slow

Deposits: ☒ None ☐ Mud ☐ Sludge ☐ Debris ☐ Grease

Infiltration: None Pipe Seal Cond: Unknown

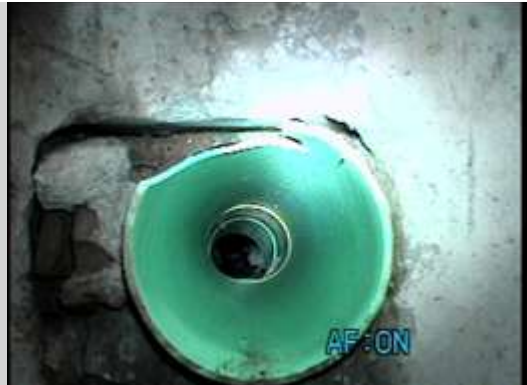
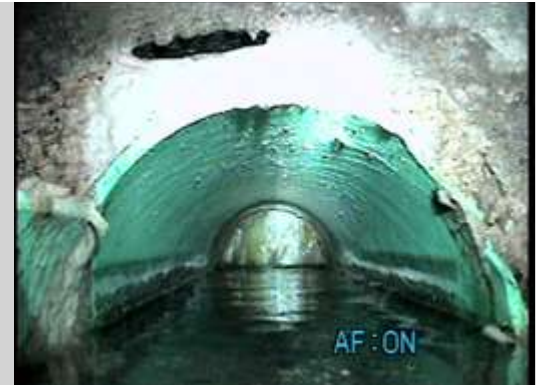
6 O'Clock Inflow

Pipe In @ 6 O'Clock

Drop In @ 6 O'Clock

Invert Depth: **13.66** (ft.) Flow Characteristics: **Slow**

Drop: **Outside** **Direct**

Inv Depth: **13.92** (ft.)

Drop Condition: **Open**
